Burst Failures of Water Cooling Rubber Pipes of TRISTAN MR Magnet Power Supplies and Magnets

Tadashi Kubo
National Laboratory for High Energy Physics
1-1 Oho, Tsukuba-shi, Ibaraki-ken 305, Japan

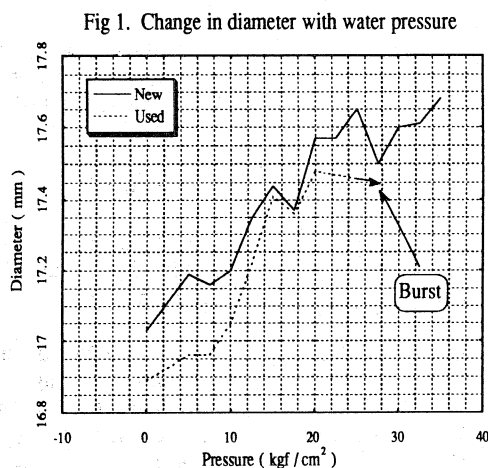
Fig 1. Change in diameter with water pressure

The thickness of the inside layer of the rubber pipes used for Q_A , Q_B and Q_C magnets are 3mm, 1.75mm and 3mm respectively. This difference affects the life of the rubber pipes essentially. It looks like that the life of the rubber pipe for Q_B magnet had been reduced extremely in accordance with the degradation of the rubber and the vinylon fiber after long time use. To confirm this fact the pressurization test was carried out for a new one and a degraded one. Fig 1. shows the result.

New one endured the pressure with 35 kgf/cm² for 10 minutes.

On July end we decided to replace all rubber pipes for Q_B

magnets and ordered the company to manufacture the improved rubber pipes of which thickness of the inside layer is 3mm.

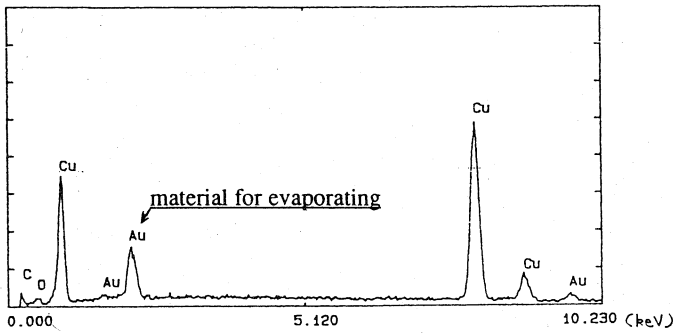
Fig 2. Qualitative analysis of the deposit

The brown colored deposit was confirmed on the surface of inner layer by the observation of two burst rubber pipes. It proved to be that this phenomenon was the decisive evidence of the failure at this time. Fig 2. shows the qualitative analysis of the deposit. As can be seen the main component of the deposit is Cu.

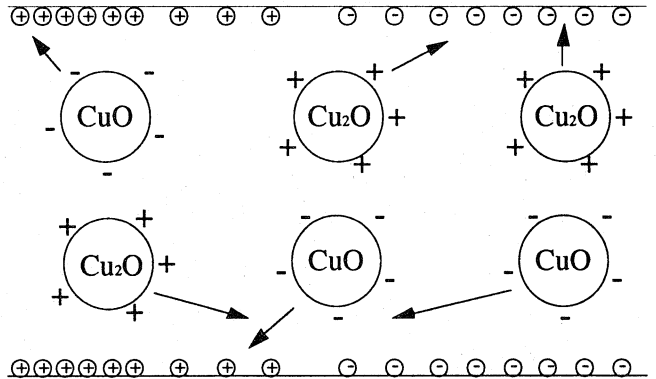
Fig 4. Appearance of the deposit

The molecules of the copper oxide and the cuprous oxide and the inner layer of the rubber pipe are charged, so the Cu oxide will be deposited on the surface of the rubber pipe by the electrostatic force. The condition of the charging depends on pH, flow velocity and temperature of water, and electric field. Fig 4. shows the appearance of the deposit of Cu oxide.

has been caused by the exchanging of S for Cu atoms in the molecular bond. And also it was found that the deposit could be seen only on the rubber pipe supplied with DC voltage.

We decided to replace all the rubber pipes which were supplied with DC voltage at both ends. The EPDM rubber pipe was adopted at this time by the reason mentioned above.
