NEW SUPPORT FOR BPM TO SEPARATE FROM Q-MAGNET

M. Yao[†], S. Terui, R. Ueki, M. Shirai, H. Yamaoka, K. Shibata,
 Y. Suetsugu, T. Ishibashi, Y. Ohsawa, M. Furusawa, T. Kawamoto,
 Y. Ohnishi, M. Masuzawa, S. Nakamura, KEK, Tsukuba, Ibaraki, Japan

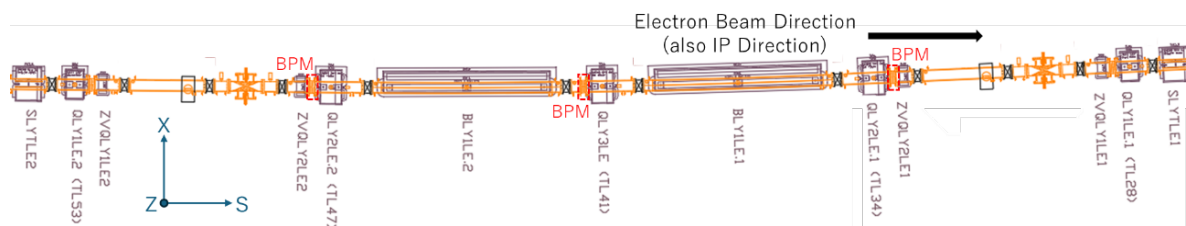
Figure 1. Magnet arrangement between two strong sextupole magnets, SLYTLE1 and SLYTLE2, in the HER (top view).

In SuperKEKB, the beam orbit distortion was found to be positively correlated with the beam current, which became an obstacle to increasing the beam current [1]. It was found that in the high energy ring (HER, electron ring), the injection efficiency was improved by the correction of the horizontal beam orbit in the Local Chromaticity Correction (LCC) region, where a pair of strong sextupole magnets is installed. This implies that the beam orbit distortion did exist in this region. The magnet arrangement between these two strong sextupole magnets is shown in a top view in Fig. 1. Among them, “S” represents a sextupole magnet, “Q” represents a quadrupole magnet (Q-magnet), “B” represents a bending magnet, and “ZVQ” represents a vertical steering magnet for beam orbit correction. The outward direction of the ring is defined as +x. One of the possible causes of the beam orbit distortion is the dipole kick from the Q-magnet (which is QLY2LE.2, QLY3LE, and QLY2LE.1 in Fig. 1) generated by the deformation of the

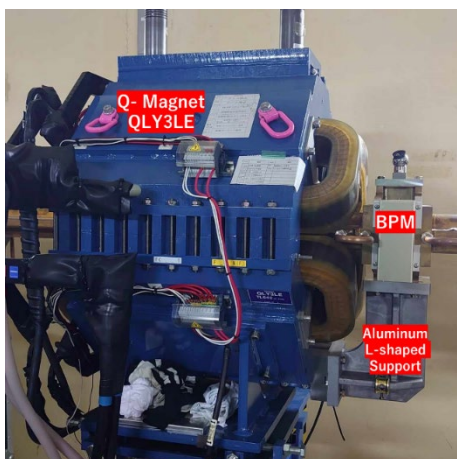
Figure 2: Original design where BPM and Q-magnet are connected via an aluminum L-shaped support.

beam pipe. Since the beam pipe with beam position monitor (BPM) and the Q-magnet are connected via an aluminum L-shaped support (later referred to as “old support”), as shown in Fig. 2, the position of the Q-magnet will also be shifted when the beam pipe is deformed by synchrotron radiation (SR) heating. Additionally, the β function in this region is large because it is close to the interaction point (IP), so even a small kick can cause a large orbit distortion. Therefore, a new support was designed for the BPM to separate it from the Q-magnet. Due to space limitations, this report will skip the details of the design process and testing without beam, focusing instead on comparing the measured displacement of the BPM and Q-magnet due to thermal deformation before and after the installation of the new support during operation.

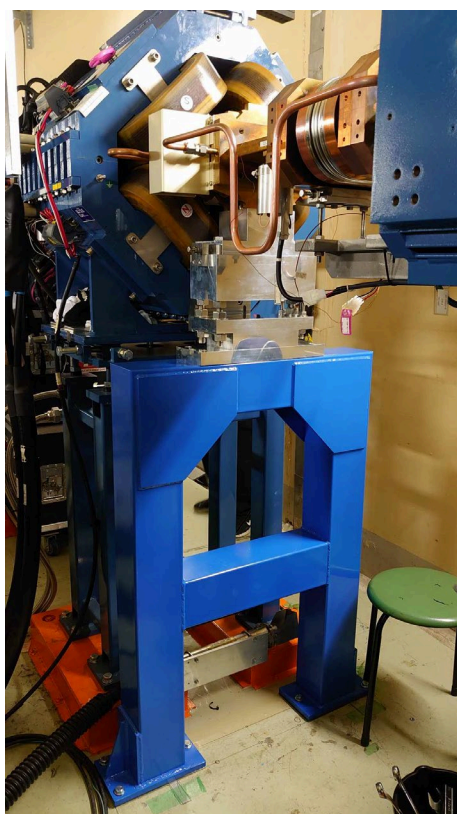
The structure of the new support is shown in Fig. 3. The lower blue trunk is composed of iron square tubes with a cross-section of 125×125 mm, and a thickness of 3 mm, and the upper silver part is made of aluminum to prevent affecting the magnetic field of the Q-magnet. During the design phase, the software Ansys was used to evaluate the strength of the support. The simulation results showed that when a horizontal force of 1000 N was applied to the BPM, the x-displacements of the BPM and Q-magnet were ~ 180 μm and ~ 100 μm , respectively, with the old support. With new support, the x-displacement of the BPM was ~ 70 μm , while the Q-magnet remained stationary.

Figure 3: New Support for BPM.

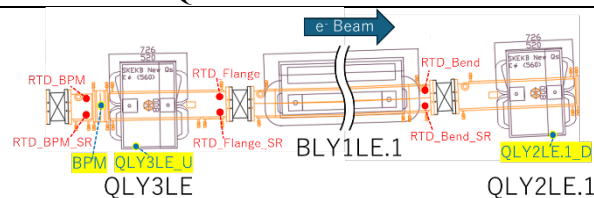
Figure 4: Top view of the beam pipe marking important measurement points in this report.

Displacement Measurement with Beam From February to July is the first operation period of SuperKEKB in 2024. The installation of the new support can be divided into three periods, which are summarized in Table 1, and the corresponding measurement settings are shown in Fig. 4. During the first period when the old support was used, two capacitive displacement sensors with a diameter of 20 mm ($\phi 20$) were installed [2], namely BPM and

QLY3LE_U, as shown in Fig. 4 and Fig. 5(a). During the second period, a new support was installed under the BPM next to QLY3LE and a new $\phi 30$ displacement sensor on QLY2LE.1_D was added, as shown in Fig. 4 and Fig. 5(b). Finally, all three BPM supports were replaced with new ones. The capacitive displacement sensor and its detector are manufactured by Sankosha Co., Ltd. The model of the detector is SKI-22181A, and its resolution is less than $0.2 \mu\text{m}$. When using a $\phi 20$ sensor, the voltage output changes linearly from -10 V to $+10 \text{ V}$ when the gap is between 0.5 and 2.5 mm . When using a $\phi 30$ sensor, the voltage output changes linearly from -10 V to $+10 \text{ V}$ when the gap is between 0 and 6 mm . In addition, fourteen resistance

temperature detectors (RTDs) were attached to the beam pipe in this region. Figure 4 only shows the six RTDs close to the displacement sensors. The ones with “SR in their names represent the side irradiated by SR.

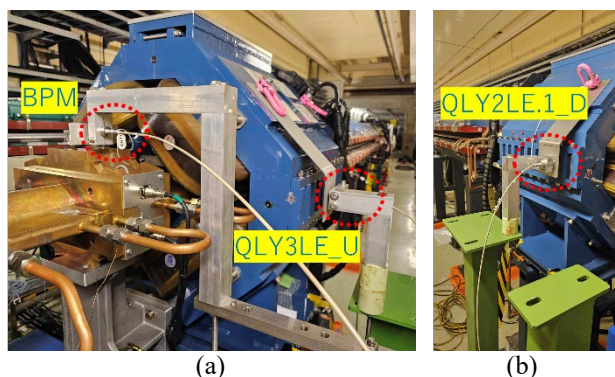
Figure 5: Photos of the three capacitive displacement sensors. (a) shows the sensors “BPM” and “QLY3LE_U”. (b) shows the sensor “QLY2LE.1_D”.

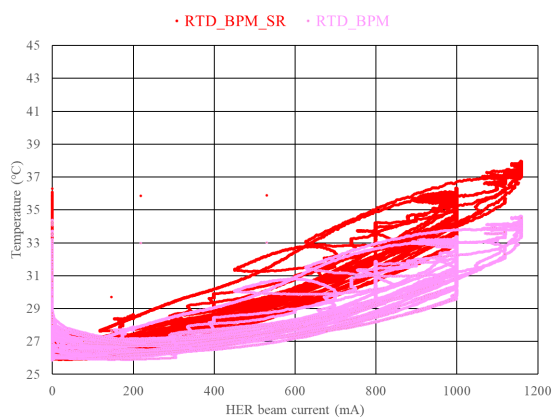
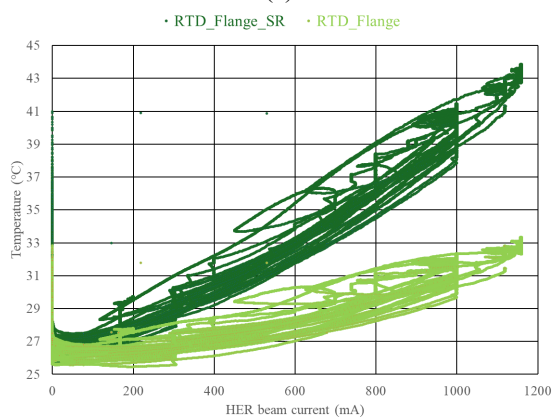
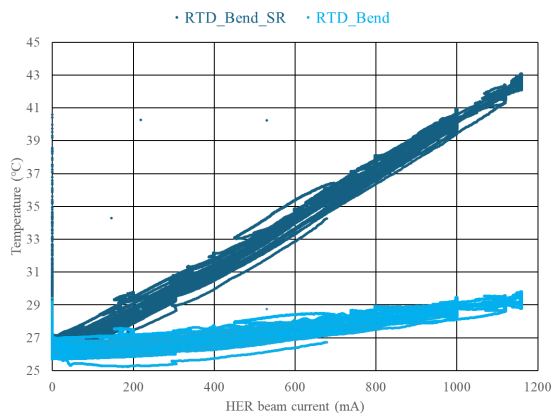
Figure 6: Relationship between temperatures on both sides of (a) BPM, (b) Flange, and (c) Bend and the beam current of HER from May 22nd to May 24th, 2024.

Figure 6 shows the relationship between the temperatures on both sides of BPM, Flange, and Bend and the beam current of HER from May 22nd to May 24th, 2024. When the beam current reached 1100 mA , the temperature differences between the two sides of BPM, Flange, and Bend were about 3 , 10 , and 13°C respectively, and the temperature of RTD_Flange_SR reached $\sim 43^\circ\text{C}$.

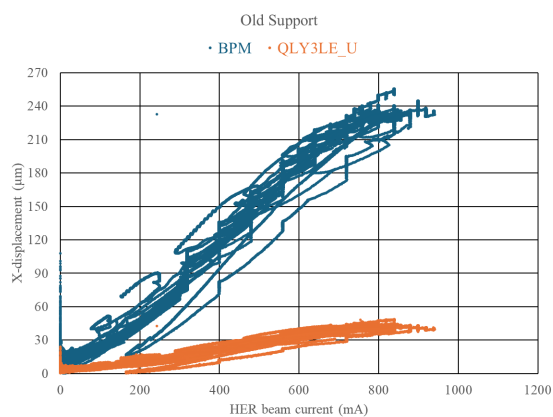
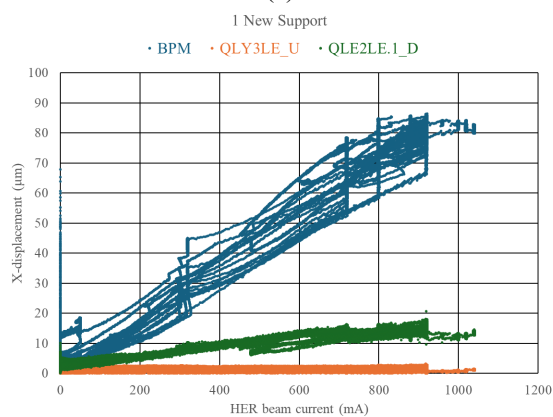
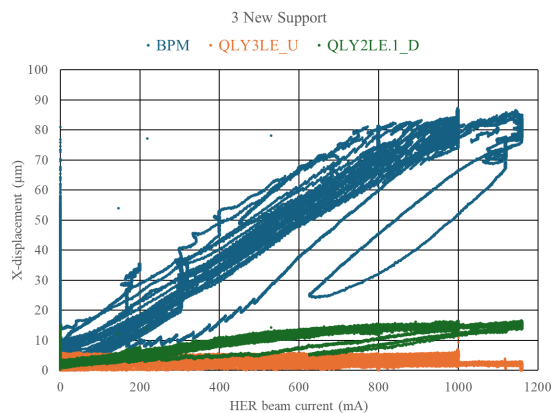
Figure 7: Relationship between x-displacements of BPM, QLY3LE_U, and BPM, QLY2LE.1_D and the HER beam current. (a) Old support. (b) One new support. (c) Three new supports.

From the three periods listed in Table 1, we selected three representative days from each period: April 14th to April 16th (0414~0416), April 28th to April 30th (0428~0430), and May 22nd to May 24th (0522~0524). Figure 7 shows the relationship between the x-displacements of BPM, QLY3LE_U, and BPM, QLY2LE.1_D, and the HER beam current for these three periods. Comparing

Fig. 7(a) and Fig. 7(b), with only one new support installed, the x-displacement of QLY3LE_U was reduced from $\sim 50 \mu\text{m}$ to $\sim 5 \mu\text{m}$ at 800 mA, and the x-displacement of BPM was reduced from $\sim 250 \mu\text{m}$ to $\sim 85 \mu\text{m}$. The effect of the new support near QLY3LE was significant. Comparing Fig. 7(b) and Fig. 7 (c), the effect of the two new supports next to QLY2LE.1 and QLY2LE.2 was difficult to observe from the displacement sensors near QLY3LE. Moreover, QLY2LE.1 still moved with the beam current even after

being separated from the beam pipe. Possible causes include the thermal deformation of the Q-magnet due to the warm beam pipe through air convection, or a defective sensor setup, which requires further research to confirm.

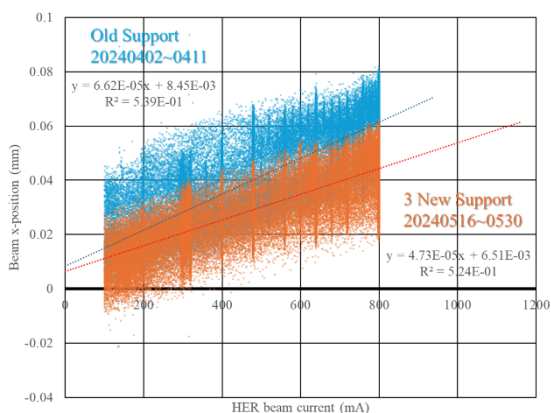
Figure 8: Relationship between beam x-position and beam current with old and new supports in HER.

The vertical axis of Fig. 8 is the average x-position of the beam measured by the BPMs next to the two strong

sextupole magnets, SLYTLE1 and SLYTLE2, and the horizontal axis is the HER beam current. We selected several days each from the old support and new support periods, and took the data from beam current 100 to 800 mA to do linear fitting. The results showed that with three new supports, the change in beam position with current (i.e., the slope) decreased.

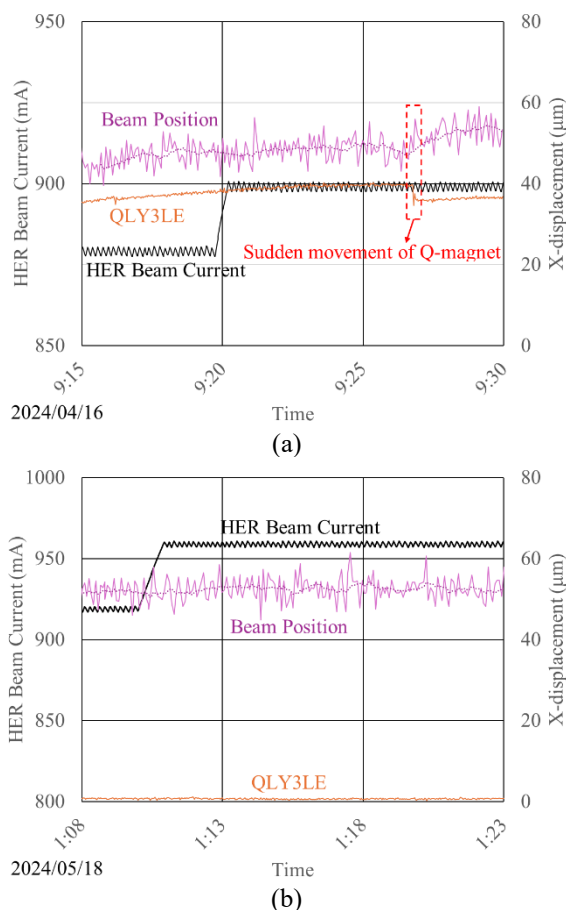
Figure 9: (a) An example of sudden displacement of the Q-magnet causing a displacement of the beam position with the old support, even when the HER current was maintained at a constant value. (b) An example of stable beam position when the Q-magnet was independent of the beam pipe.

Besides, when using old support, it was frequently observed that the x-position of QLY3LE suddenly shifted while the beam current of the HER remained fixed. Figure 9(a) shows an example of such an event. It can be seen that the sudden displacement of QLY3LE caused the x-position of the beam to jump. Approximately 30 such jumps were recorded in the first half of April, all of which occurred when the beam current was above 720 mA. The sudden movement of the Q-magnet could complicate the beam tuning and has the potential to lead to a beam abort. After the new support was used to separate the Q-magnet from the beam pipe, these jump events disappeared. One example is shown in Fig. 9(b).
